Detection of Simultaneous Mechanical Faults in 6 kV Pumping Induction Motors Using Combined MCSA and Stray Flux Methods

Gyftakis, K, Panagiotou, P & Spyrakis, D 2021, 'Detection of Simultaneous Mechanical Faults in 6 kV Pumping Induction Motors Using Combined MCSA and Stray Flux Methods', *Iet electric power applications*, vol. 15, no. 5, pp. 643-652. <https://doi.org/10.1049/elp2.12054>

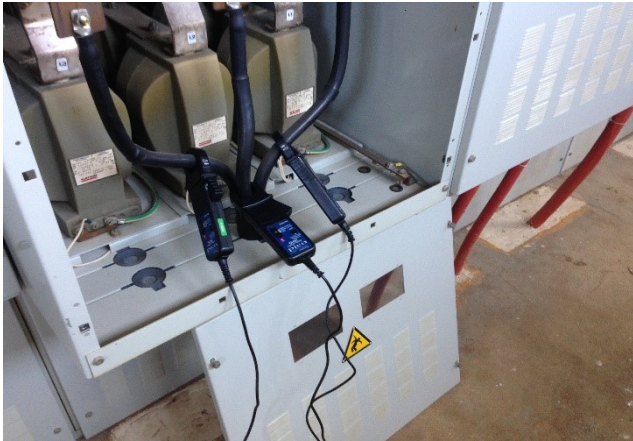
Fig. 5. Installation of the current sensors at the terminals of the induction motor.

The four motors were operating under rated conditions when the condition monitoring took place. More specifically, current clamps were installed to each motor's supply to capture the stator current waveforms (Fig. 5). At the same time, flux sensors were placed on the motors' bodies. Aiming to detect possible faults with axial impact, such as a possible level of inclined eccentricity or a bent shaft, two flux sensors were installed on each motor perfectly aligned and in parallel with the motor shaft. Their surface is perpendicular to the radial direction, thus they monitor a combination between axial and radial flux. However, due to their long distance from the ends of the machine, the main dominant contributor is the radial flux component. The installed flux sensors on one of the motors are illustrated in the following Fig. 6.

The stator current measurements were carried out without an MCSA commercial equipment. Current clamps were used with a sensitivity of 10 mV/A and an accuracy of $\pm 1\%$ of reading at $\pm 100/\pm 500$ mA. Providing a safety BNC connector, this measurement was at later stage logged onto a digital high resolution buffer memory unit used for acquisition of signal waveforms and data. All three stator currents were recorded for 3-phase inspection and detection of possible asymmetries.

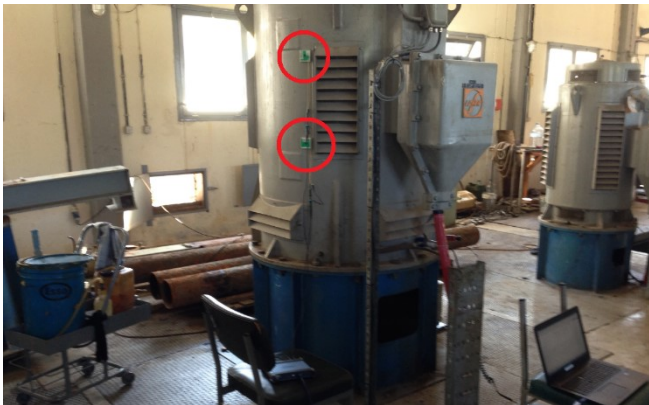
Fig. 6. Installation of the flux sensors in parallel to the motor shaft.

There are two options for monitoring the stray flux namely the rigid coil sensors and Hall sensors. In this case, coil sensors have been applied. The sensors were built in the lab using a custom made winding machine and a 3D printer. The sensors geometrical features are shown in Fig. 7.

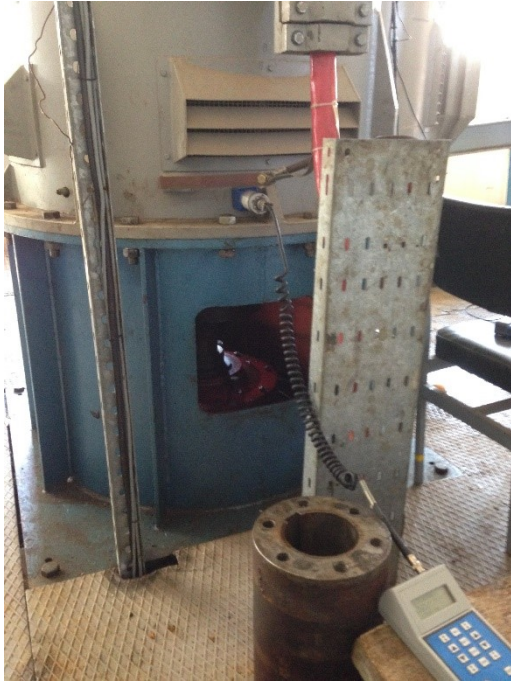
Fig. 12. Displacement measurements with the oscillometer at the load side of Motor 5.

The use of the oscilloscope at the induction motor's load side is presented in Fig. 12. Detailed recordings were taken at the motor and the pump sides.

- Upper motor part (x-axis 35 μm p-p, y-axis at direction of the discharge tube 27 μm p-p).
- Lower motor part (x-axis 18 μm p-p, y-axis at direction of discharge tube 20 μm p-p).
- Middle pump part (x-axis 120 μm p-p, y-axis at direction of discharge tube 110 μm p-p).
- Lower pump part (x-axis 72 μm p-p, y-axis at direction of discharge tube 70 μm p-p, z-axis 70 μm p-p).

The additional investigation using the oscillometer lead to the conclusion that increased oscillations appeared at the middle and lower part of the pump. The diagnostic outcome from the motor's behaviour led to the conclusion that the observed electromagnetic index was due to shaft misalignment causing faster ageing of the bearings and possible impeller damage. Therefore, the shaft had to be dismantled (Fig. 13) and the impeller replaced. The inspection showed extensive degradation of all of them.

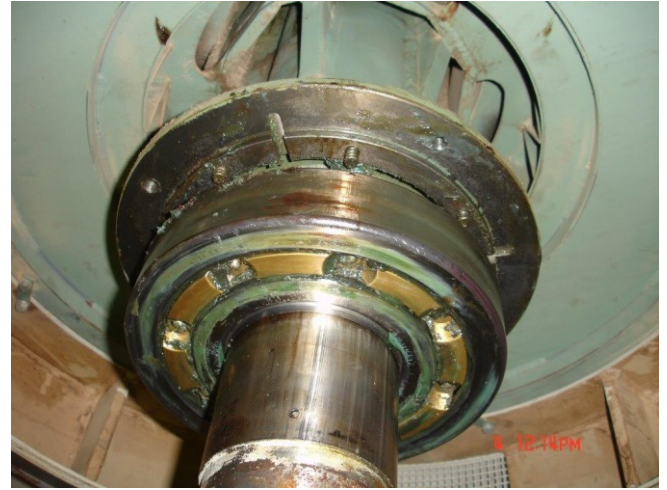
Fig. 14. The motor without protective side covers: (a) before and b) after the bearings replacement.

A degradation of the load part with such degradation severity level was improbable to have left the motor completely intact. That logical conclusion however was not supported by the measurements. On one hand, the MCSA analysis did not reveal any important eccentricity harmonics in the stator current, while on the other the oscillometer readings were quite low and non-alarming. Despite that, since the system was not operational due to the load repair, a decision was made to inspect the induction motor as well. The inspection also revealed that the misalignment had actually caused significant damage at the induction motor's bearings, which also had to be replaced (Fig. 14). The damage was distributed in a uniform manner along the circumference of

the bearings. Interestingly though, the degradation had affected the bearings in the axial direction and not the radial, possibly due to axial oscillations. It has been concluded that, the vertical alignment of the installation together the uniform degradation of the motor's bearings were probably shielding the fault's existence from both diagnostic approaches applied in this work.
